# BEAR'S BOTTOM BAY

## ONTARIO

**Bear's Butt quick reference...**

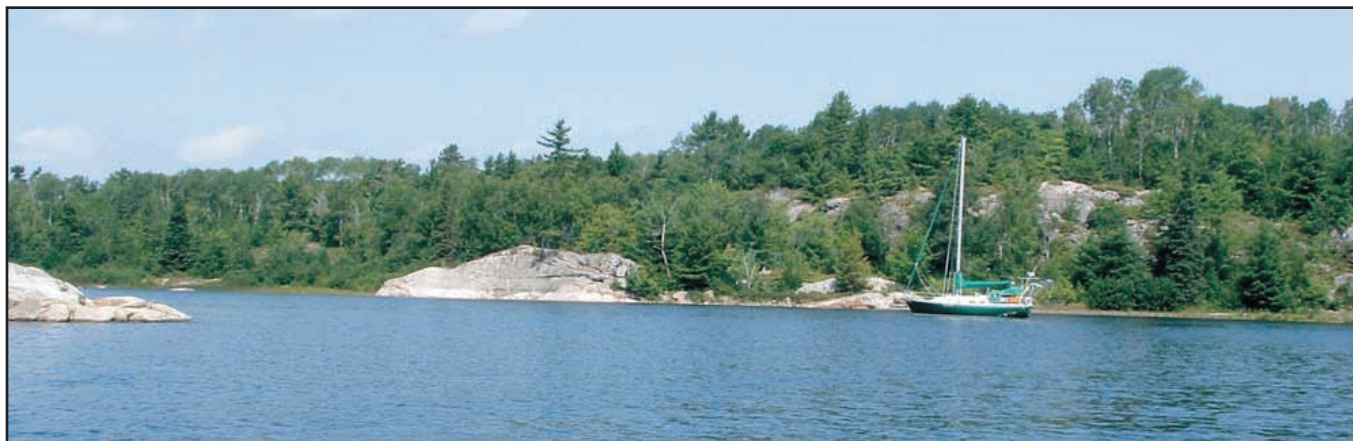
*Looking northwest over the bay. The point on the left is the south edge of the bay. Photo by Venetia Moorhouse...*

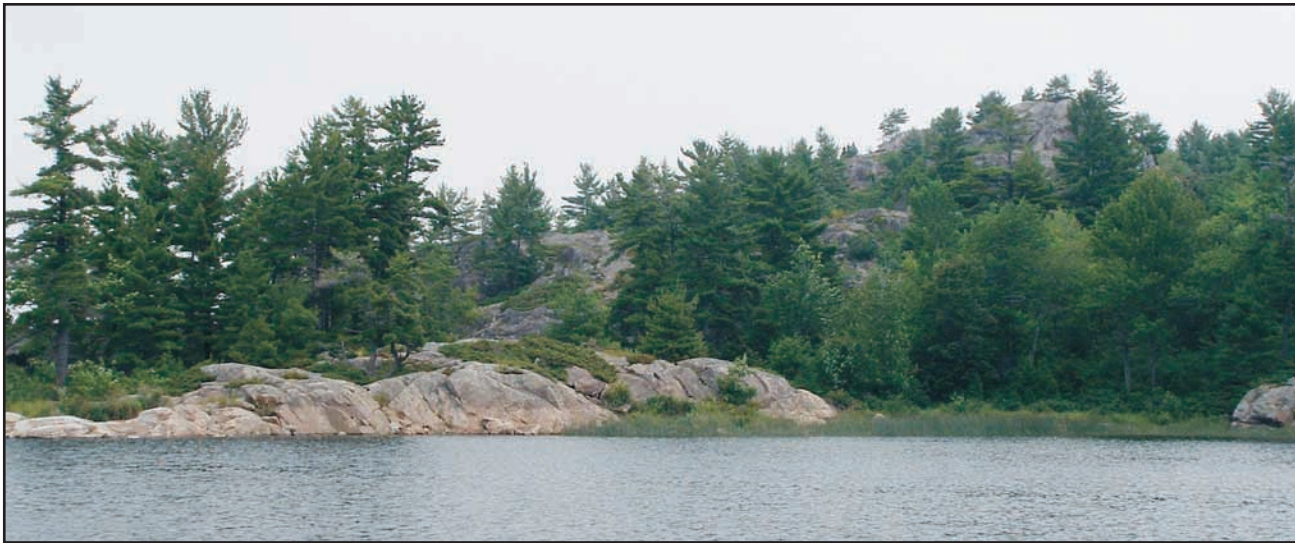
The cove gradually shallows from 13 to 14 feet at the entrance to 5 to 6 feet in the northwest corner. Anchor in 8 to 10 feet in the middle of the cove. Note that there are some rocks along the south shore, just off the reeds. Bottom is clay.

Above: Looking at the south shore. Photo by Venetia Moorhouse...
